AT3 Chipset Errata

D00001452 Rev 1.0

This document describes the known exceptions to the datasheet of AT3 chipsets. Workarounds or fixes are provided.

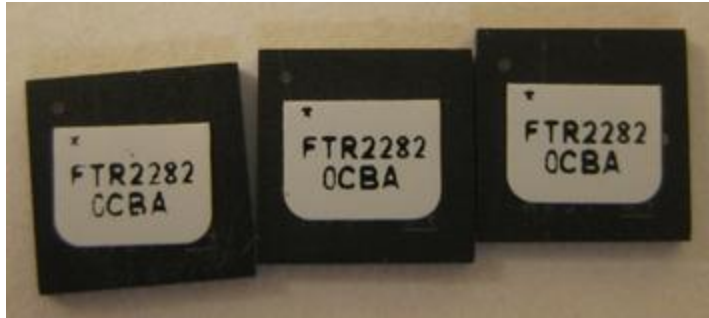
1.1 ANT MCU Tracking Code

Each AT3 MCU has a 4 character tracking code printed on the product sticker. The third character denotes the revision. The picture shows that the ANT MCU is rev B.

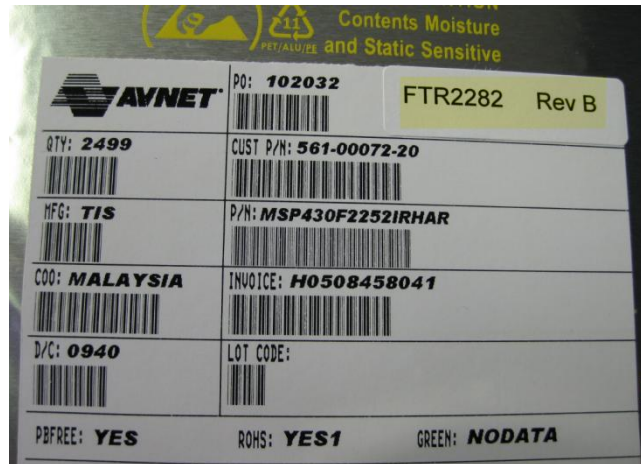
1.2 Package Label

For sealed reels, the revision is marked on the package Label as below
