AT3 Chipset Errata

D00001452 Rev 1.0

This document describes the known exceptions to the datasheet of AT3 chipsets. Workarounds or fixes are provided.

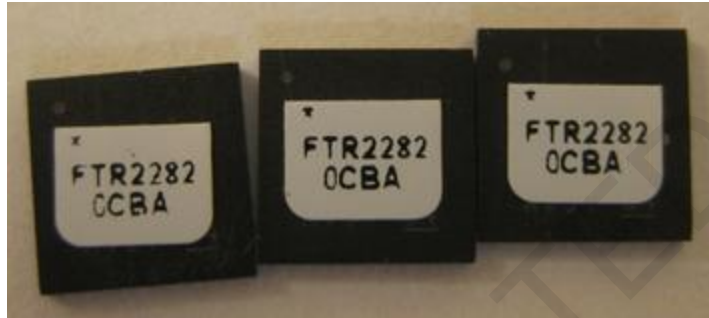
Each AT3 MCU has a 4 character tracking code printed on the product sticker. The third character denotes the revision. The picture shows that the ANT MCU is rev B.

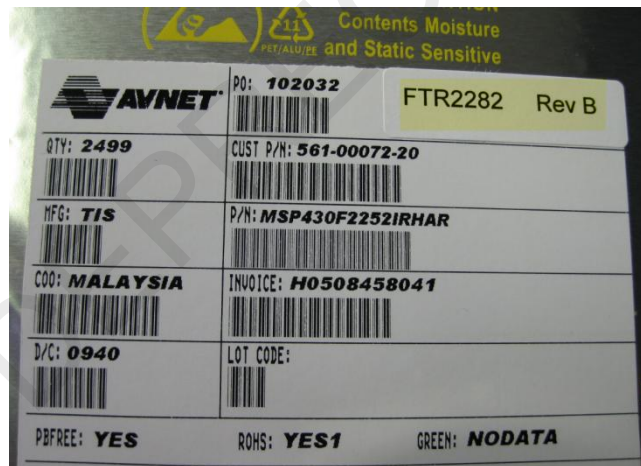
For sealed reels, the revision is marked on the package Label as below
