Revision History - AP2 RF Transceiver Module

D00001363 Rev1.5

1. Module Revision

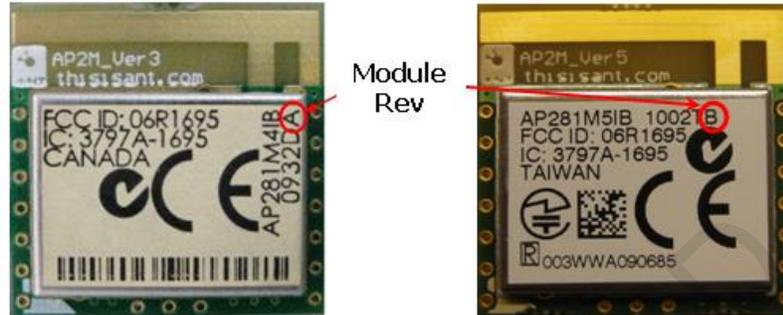
AP281MxIB module revisions are visually identified by the last character of a 6 character tracking code as illustrated:

Note: Revision 4 modules do not have RF regulatory approval markers, but a plain sticker with product name and the 6-character tracking code.
